Manhole Inspection Summary

Manhole # S19K1_026MH

Inspection ☐ Is Incomplete Rating: **3) Fair**

Location Address: **puget st**

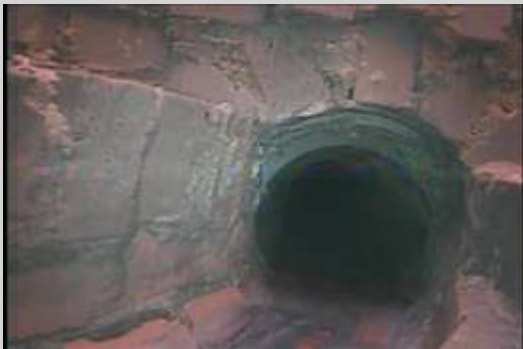
3 O'Clock Inflow

Pipe Height: **8.4** (in.) Rod and Bar (Angled)
Pipe Material: **Clay** ☐ Pipe Lined
Invert Depth: **7.96** (ft.) Flow Characteristics: **Slow**
Deposits: ☒ None ☐ Mud ☐ Sludge ☐ Debris ☐ Grease
Silt Depth: **0** (in.) Deposits Extent:
Infiltration: **None** Pipe Seal Cond: **Sound**

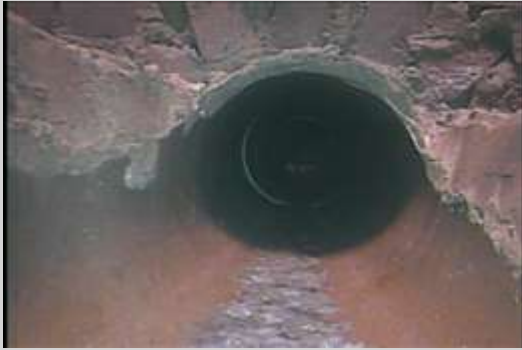
6 O'Clock Inflow

Pipe Height: **8.4** (in.) Rod and Bar (Angled)

Infiltration: **None**
